Technical Report CHL-97-25  
August 1997

# **Model Study of the Confluence of San Juan Creek and Trabuco Creek, Orange County, California**

## **Hydraulic Model Investigation**

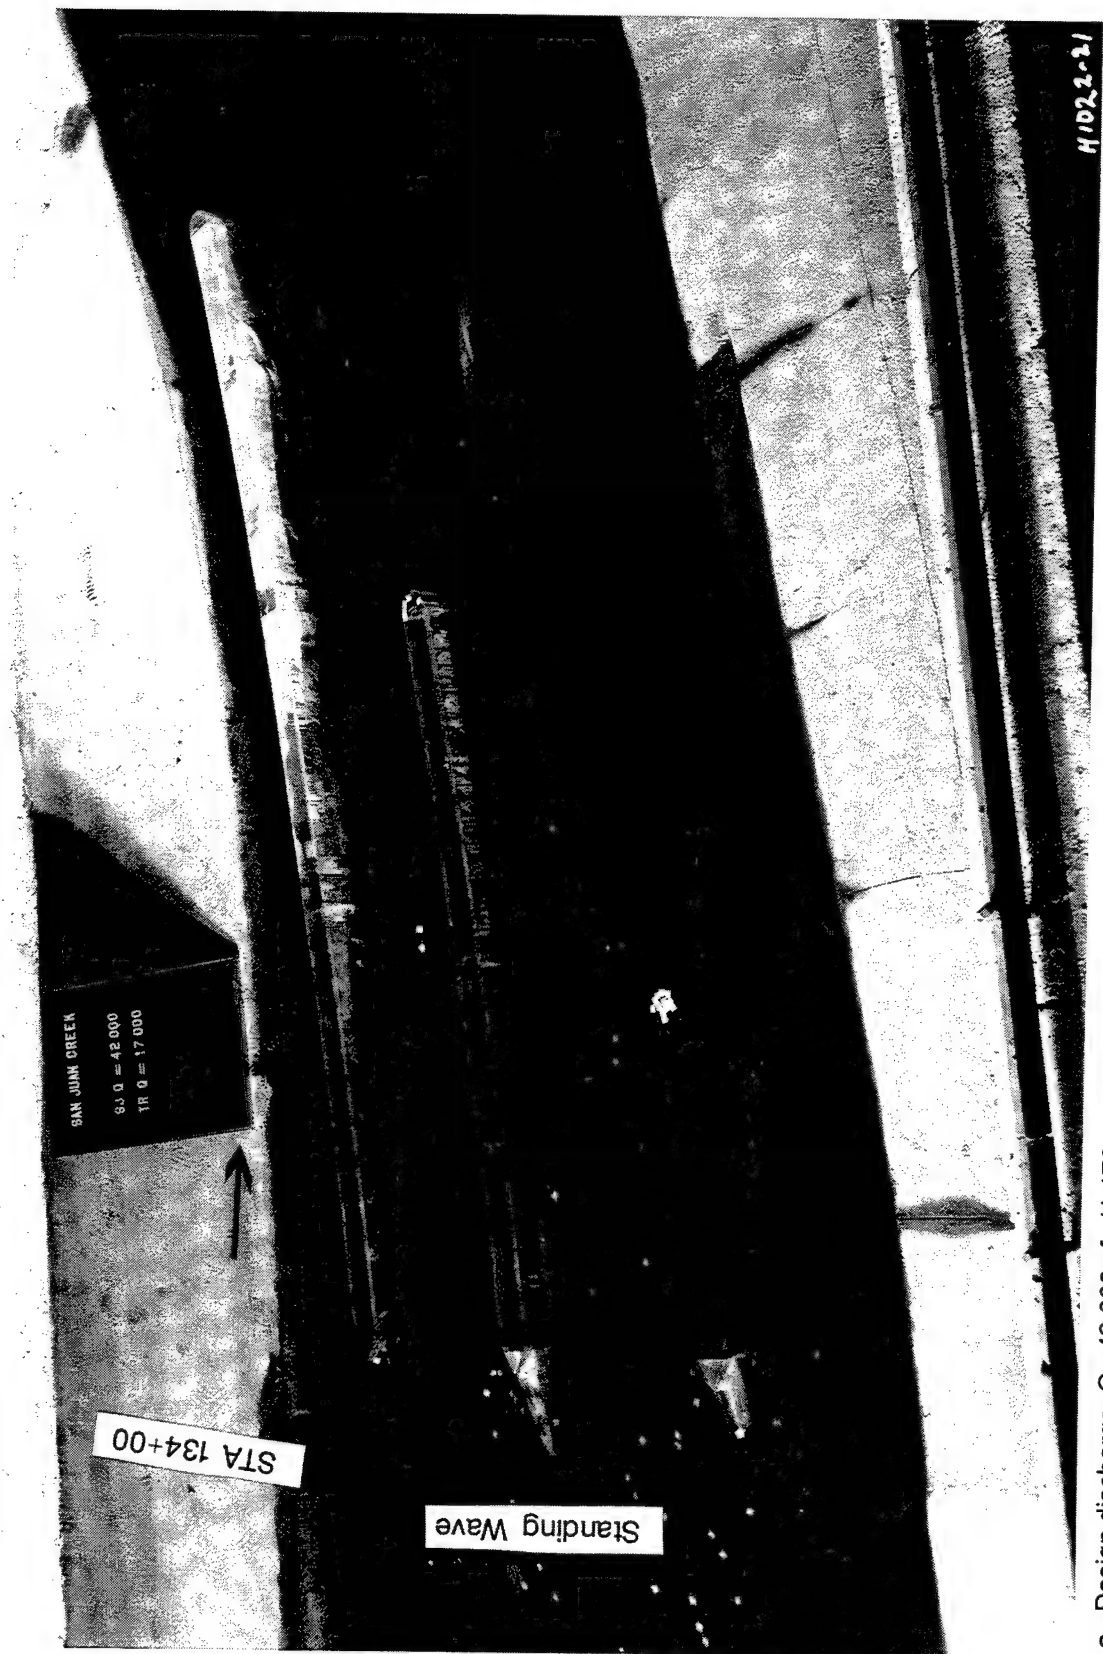
a. Design discharge,  $Q_{sj}$  42,000 cfs (1,176 cu m/sec)

Photo 9. San Juan Creek, type 6 design, flow conditions in the vicinity of the railroad bridge piers, side view. A prominent standing wave extended the width of the channel, induced by a change in slope of channel invert by a decrease in flow area. (Sheet 1 of 3)

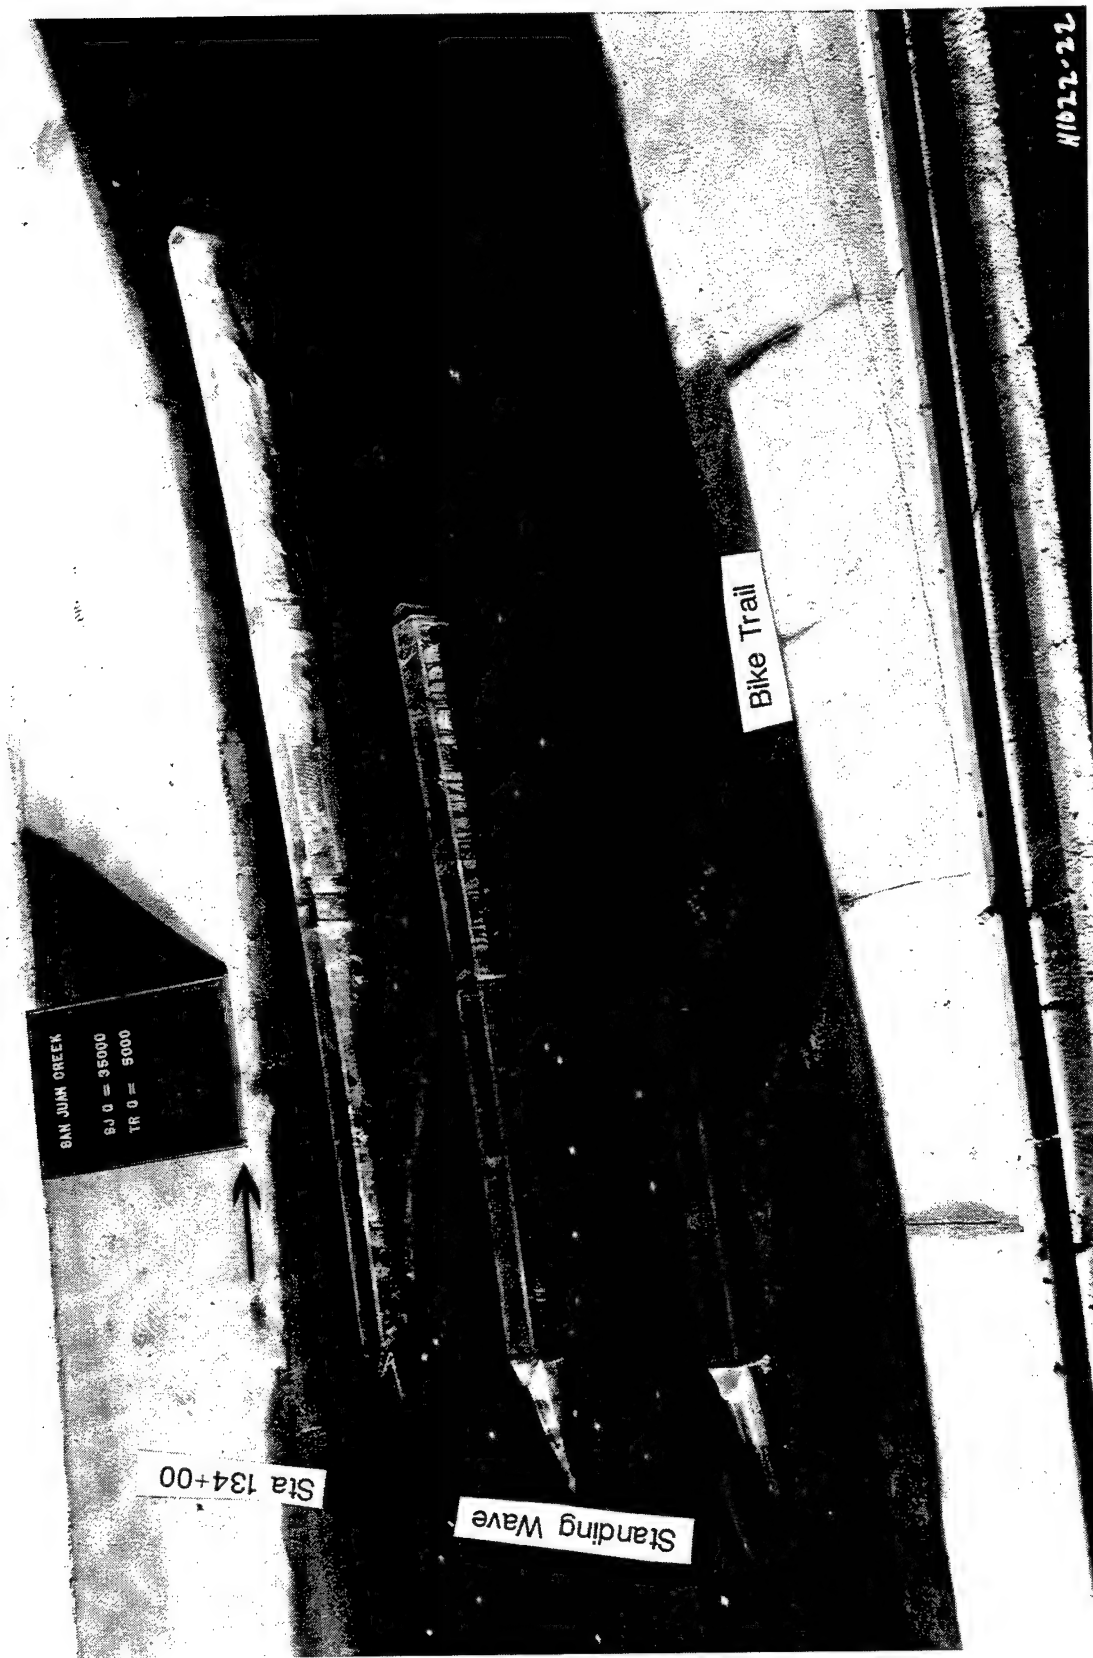
Photo 9. (Sheet 2 of 3)

b. Unbalanced discharge,  $Q_{sj}$  35,000 cfs (980 cu m/sec)

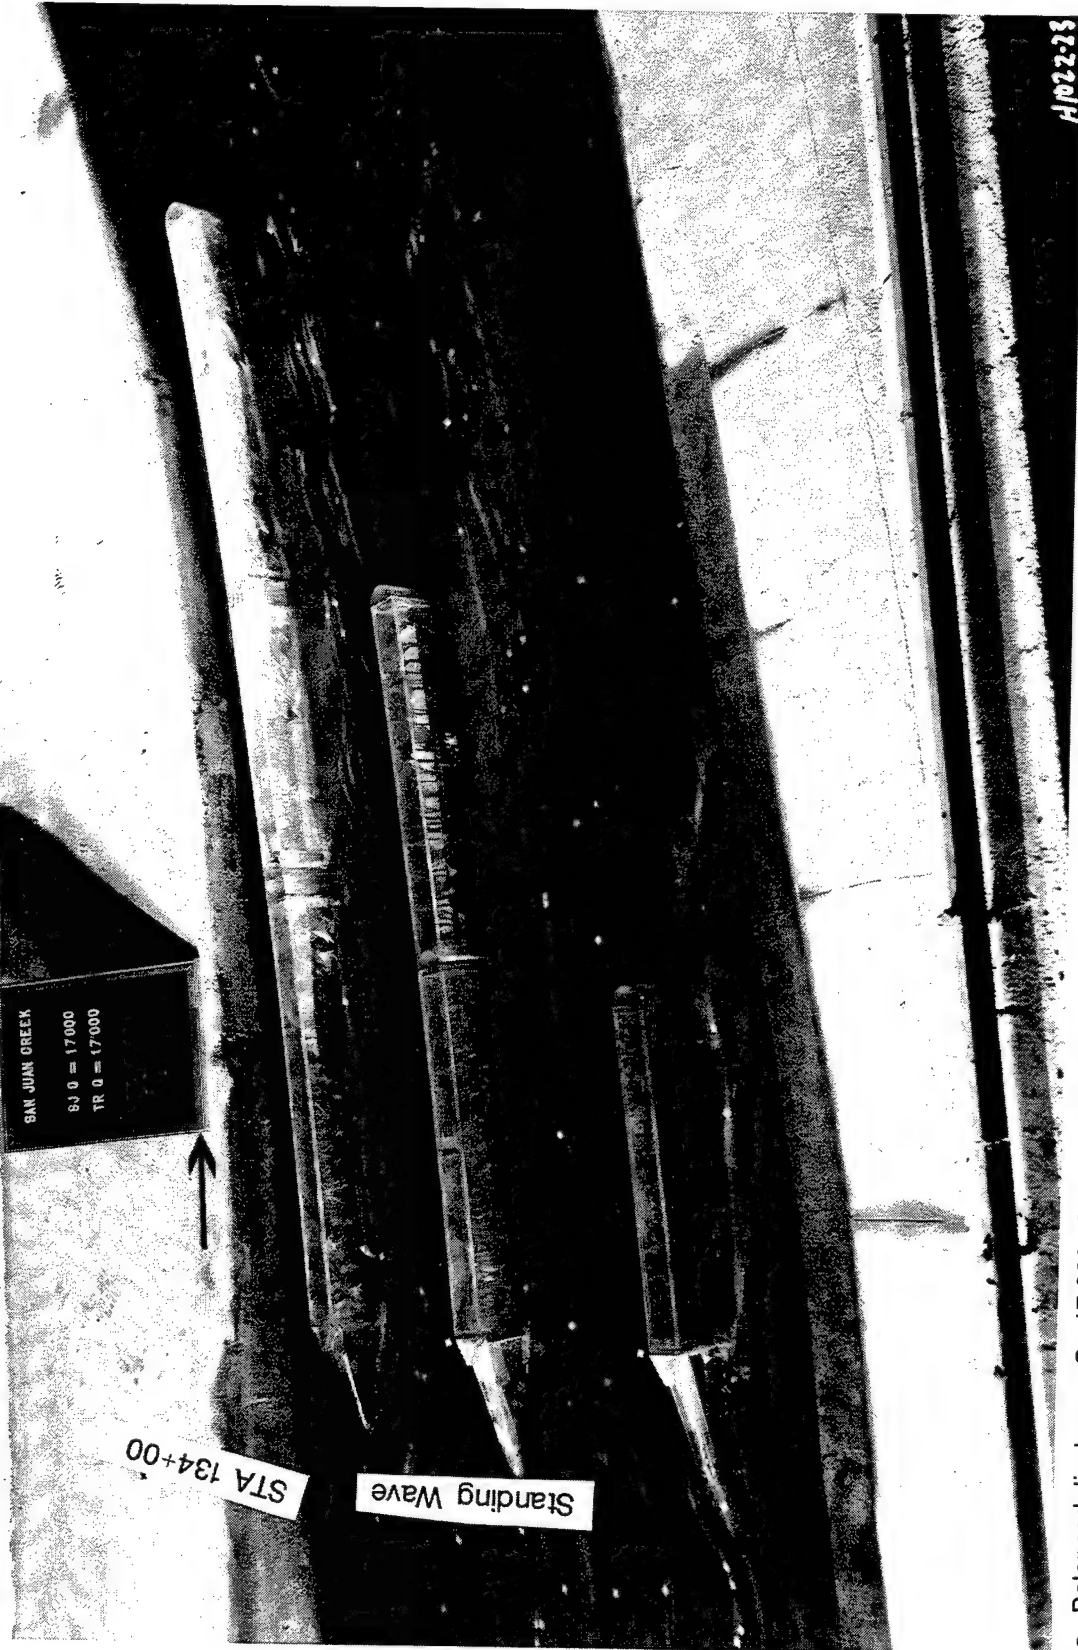
SAN JUAN CREEK  
SJO = 17000  
TR 0 = 17000

**Balanced discharges.** Various flow conditions for the balanced discharges (San Juan Creek and Trabuco Creeks 17,000 cfs (476 cu m/sec)) for the type 6 design are shown in Photos 9c and 10c. Standing waves were observed downstream of the railroad bridge (Photo 10c), and a standing wave expanding across the channel was observed at sta 134+00 (Photo 9c). Flow separation was observed on both the left and right banks at sta 135+00 and 134+50, respectively (Photo 10c). Flow conditions in the vicinity of the railroad bridge were better without the pier extensions.

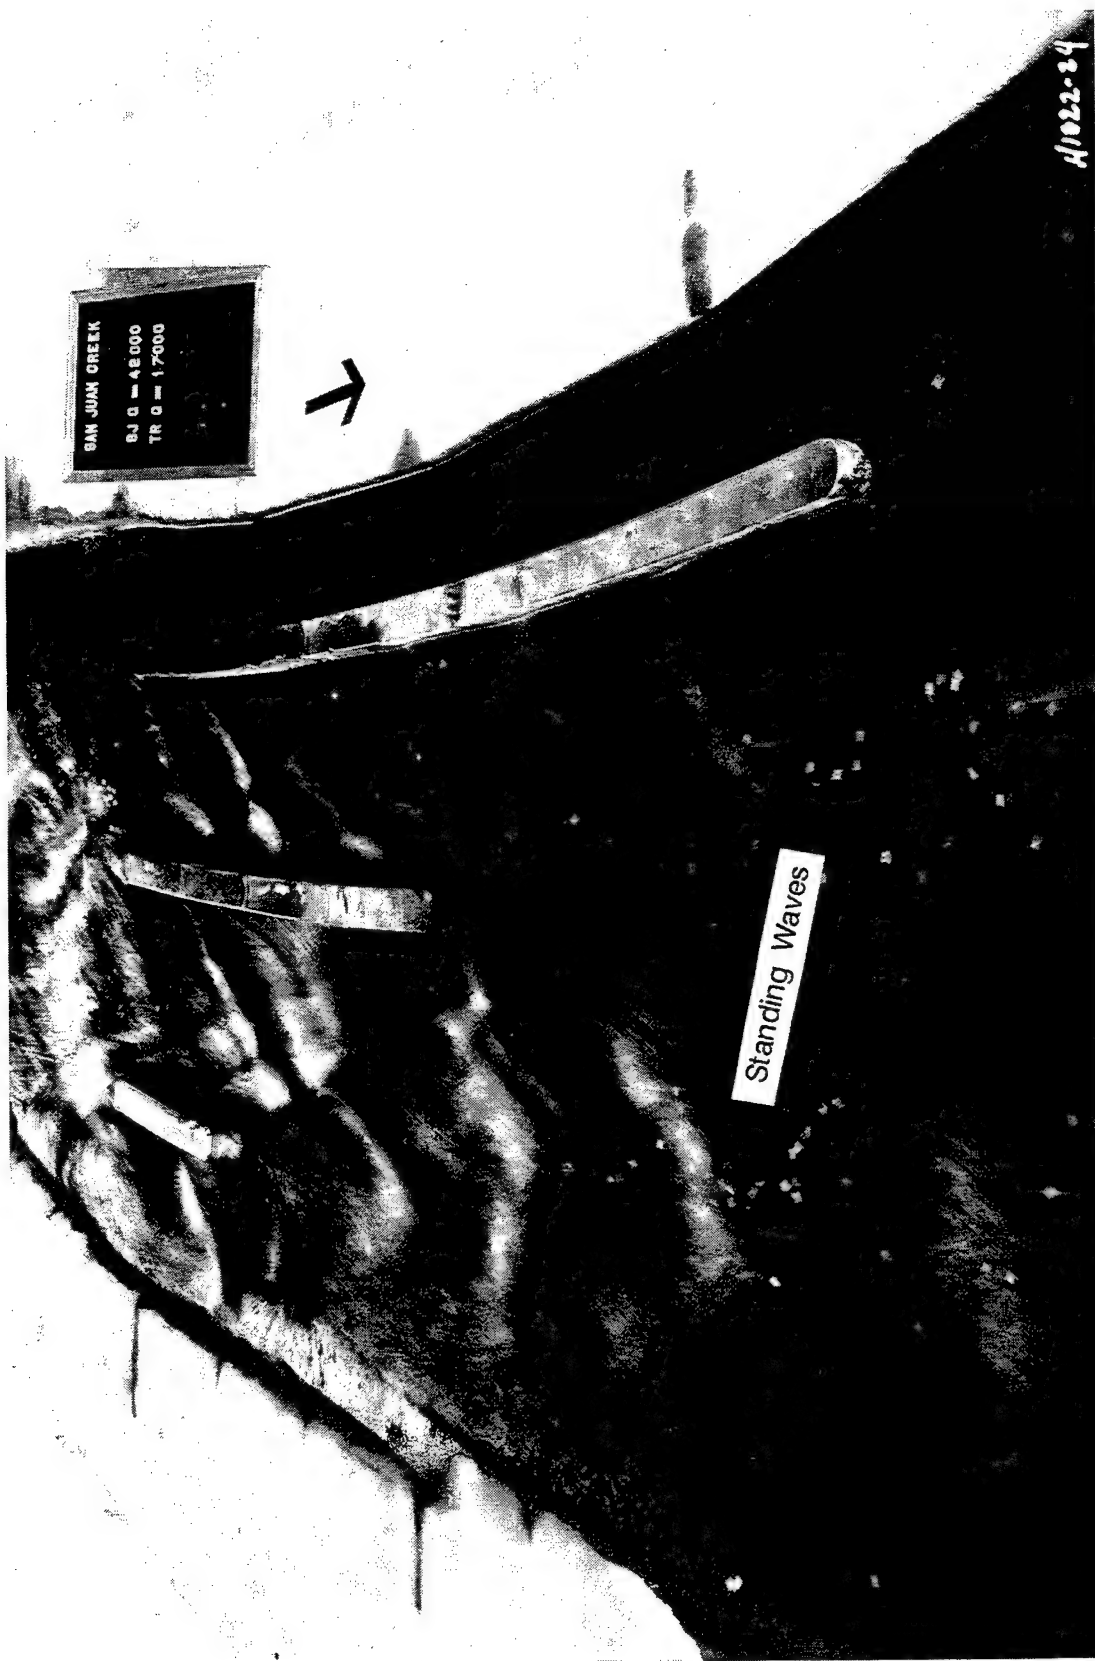
a. Design discharge,  $Q_{sj}$  42,000 cfs (1,176 cu m/sec)

Photo 10. San Juan Creek, type 6 design, flow conditions in the vicinity of the railroad bridge piers, upstream view. Standing waves observed downstream of the railroad bridge piers, created by flow separation on left and right banks and the bridge piers (Sheet 1 of 3)

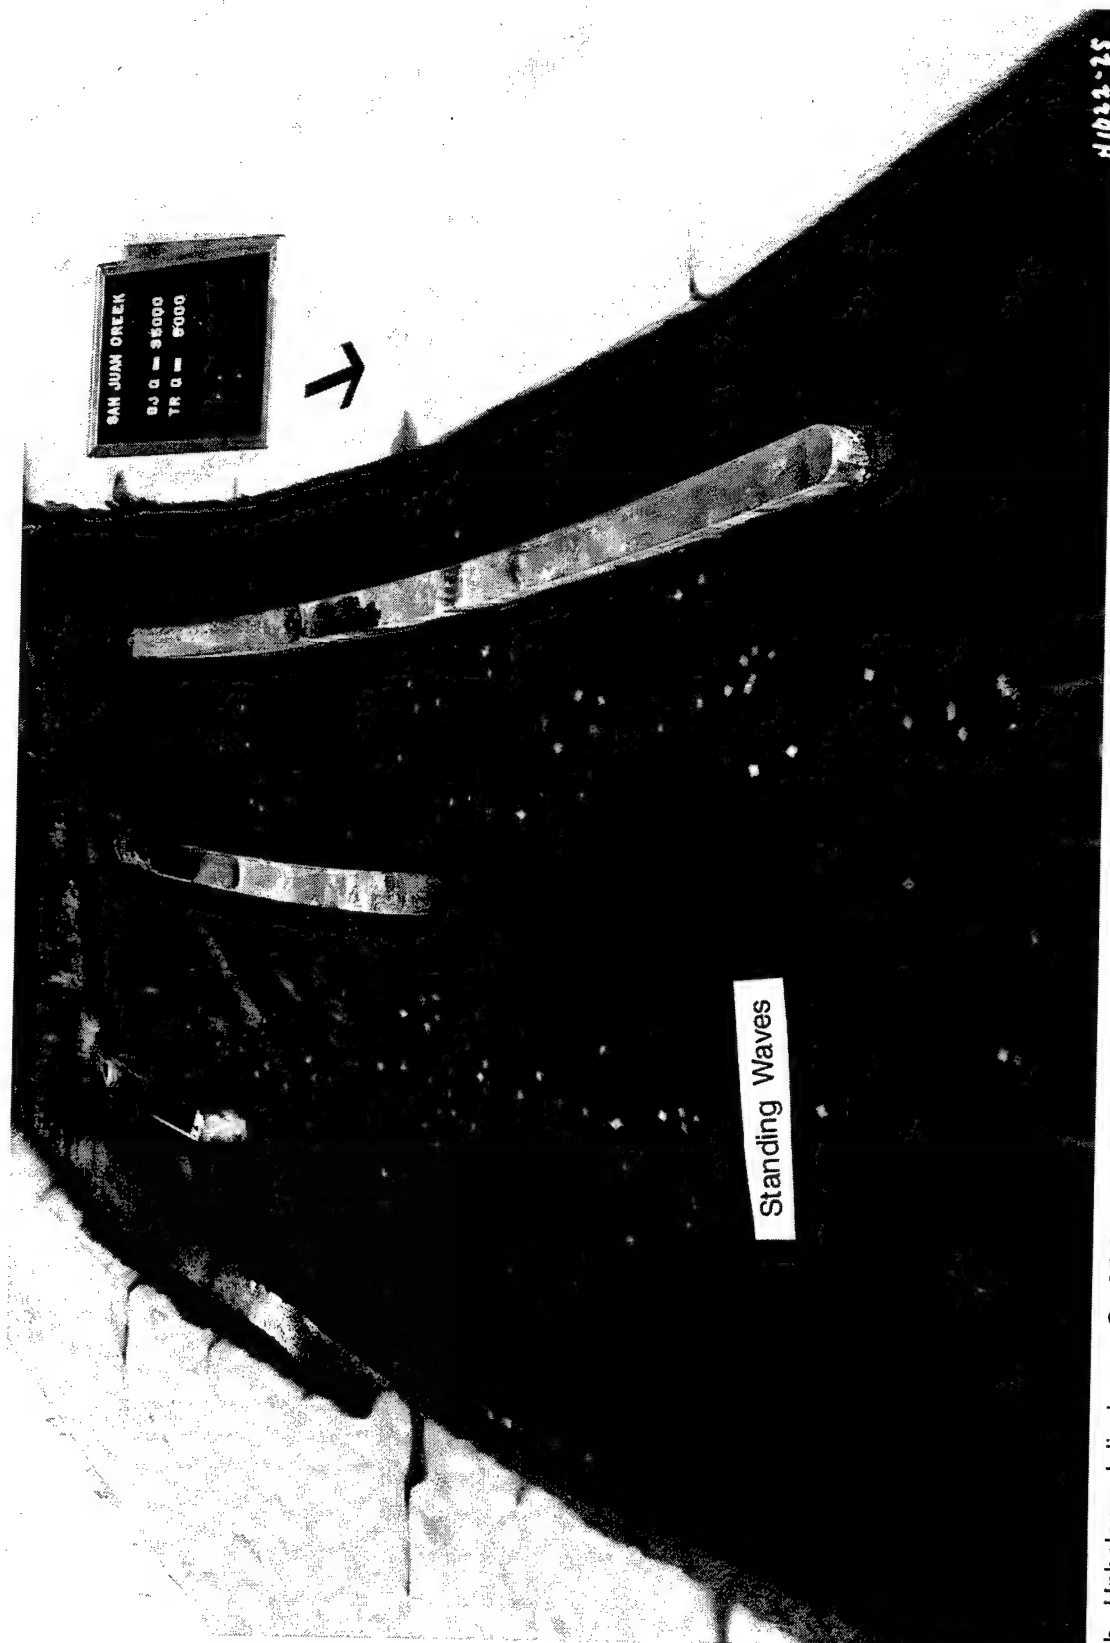
Photo 10. (Sheet 2 of 3)

b. Unbalanced discharge,  $Q_{sj}$  35,000 cfs (980 cu m/sec)

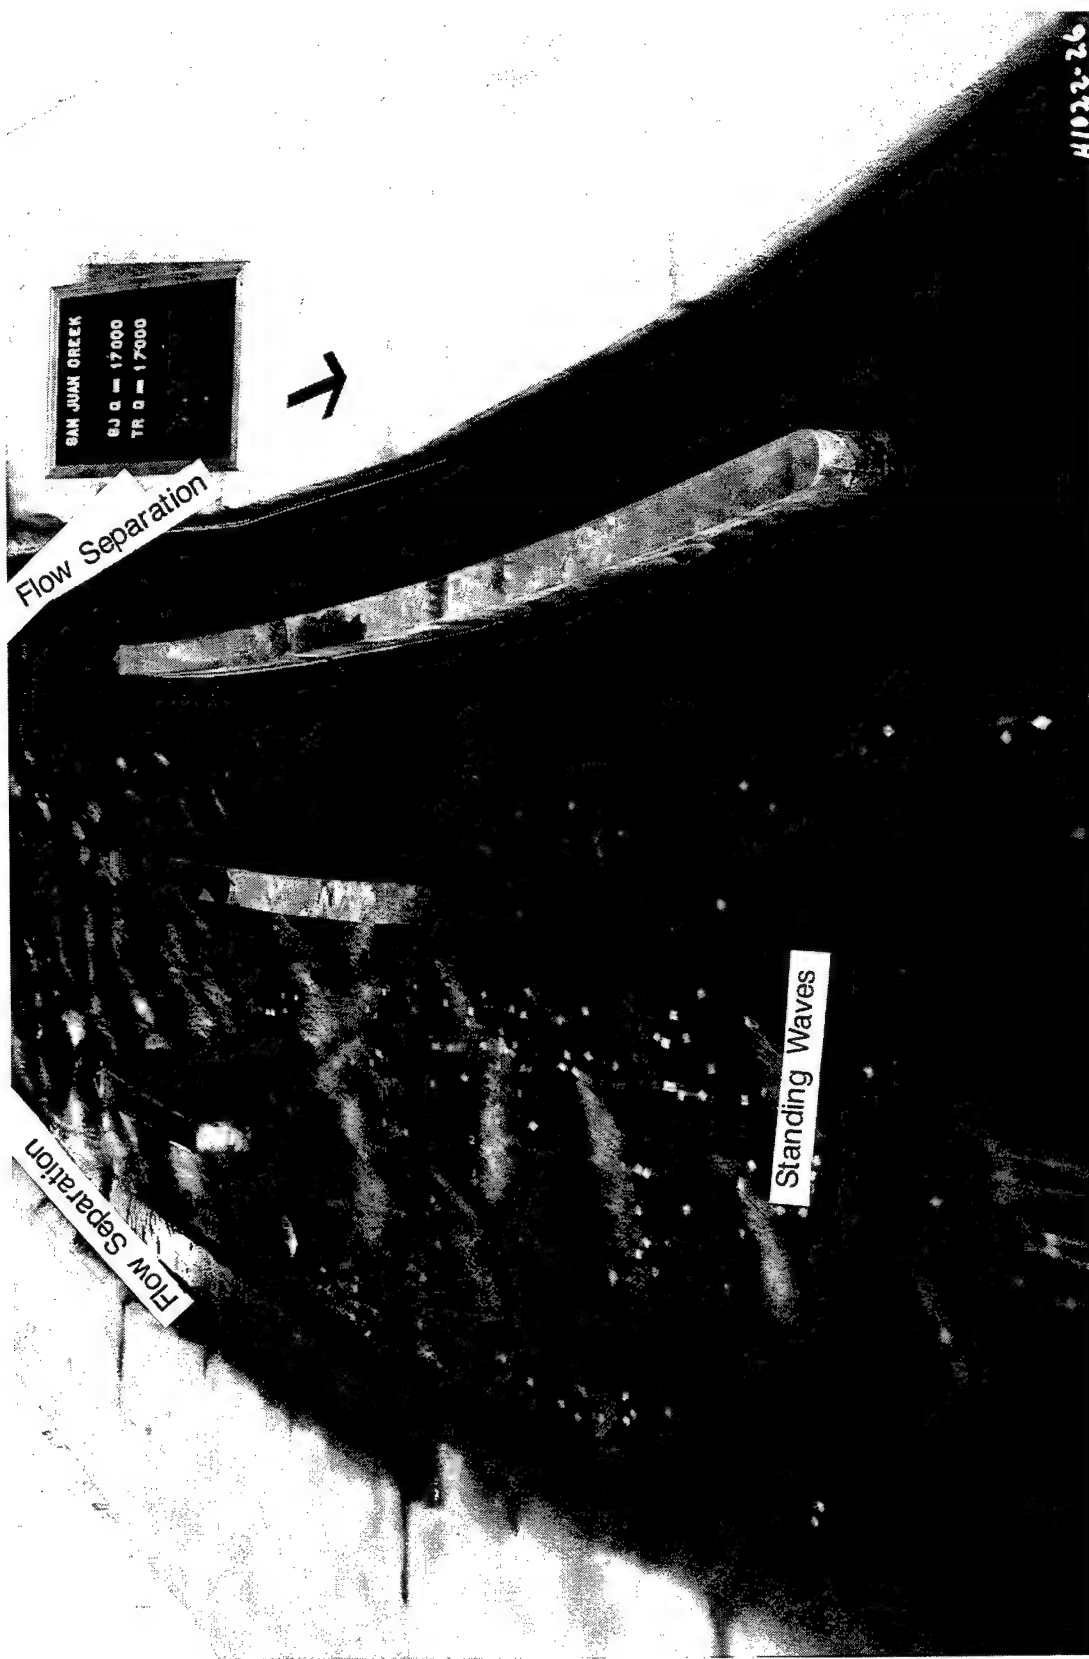
Photo 10. (Sheet 3 of 3)

c. Balanced discharge,  $Q_{aj}$  17,000 cfs (476 cu m/sec)

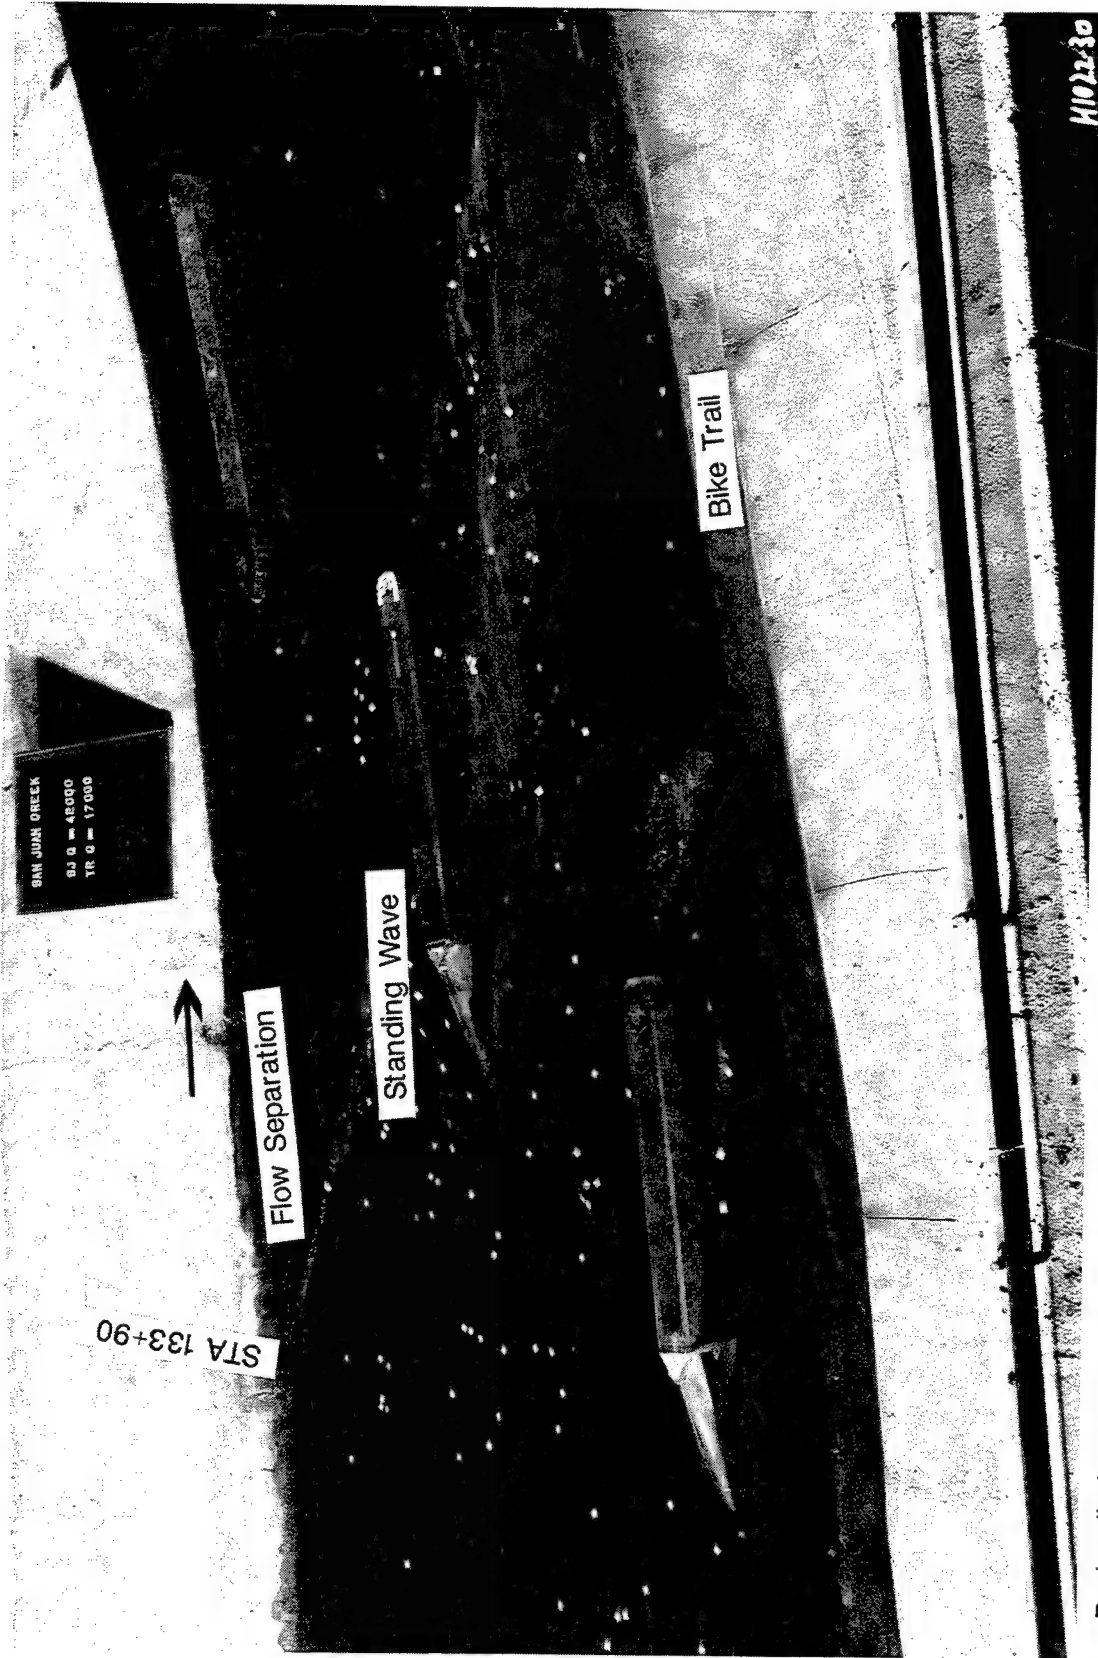
a. Design discharge,  $Q_{sj}$  42,000 cfs (1,176 cu m/sec)

Photo 11. San Juan Creek, type 7 design, flow conditions in the vicinity of the railroad bridge piers, side view. Flow separation observed on left bank created the standing wave near the center railroad bridge pier. Depth of flow increased at nose of bridge piers and then decreased. (Sheet 1 of 3)

**Design discharges.** The type 7 design consisted of the type 6 design without the pier extensions (Plate 37). Water-surface profiles recorded for the design discharges in San Juan Creek (42,000 cfs (1,176 cu m/sec)) and along the railroad bridge piers are shown in Plates 38 and 39, respectively. Water-surface elevations used to plot the profiles are given in Tables 7 and 8. Velocities measured 1 ft (0.3 m) above the bottom in San Juan Creek are shown in Plates 40 and 41. Standing waves of approximately 4 to 5 ft (1.2 to 1.5 m) in height were observed downstream of the railroad bridge piers and were created by the railroad bridge piers (Photo 11a). Flow separation that occurred on the

left bank at approximately sta 133+90 was created by the transition from a 1V:1H slope to a vertical wall (Photos 11a and 12a). A standing wave was observed at sta 133+00 near the center railroad pier (Photo 11a) and was caused by the flow separation. Flow separation also occurred on the right bank at sta 134+50 and was created by the bike trail (Photo 12a). Depth of flow along the piers tended to increase at the nose of the piers and then decrease just downstream of the nose (Plate 39, Photo 11a). This change in flow depth caused the velocities along the pier to significantly increase just downstream of the nose (Plate 40). An oblique standing wave was observed between the center and left piers at sta 131+70 (Photo 13a). The transition to return the vertical wall back to a 1V:1H slope also caused flow separation to occur on the left bank at approximately sta 125+00. Satisfactory flow conditions were observed in San Juan Creek downstream of sta 124+00.

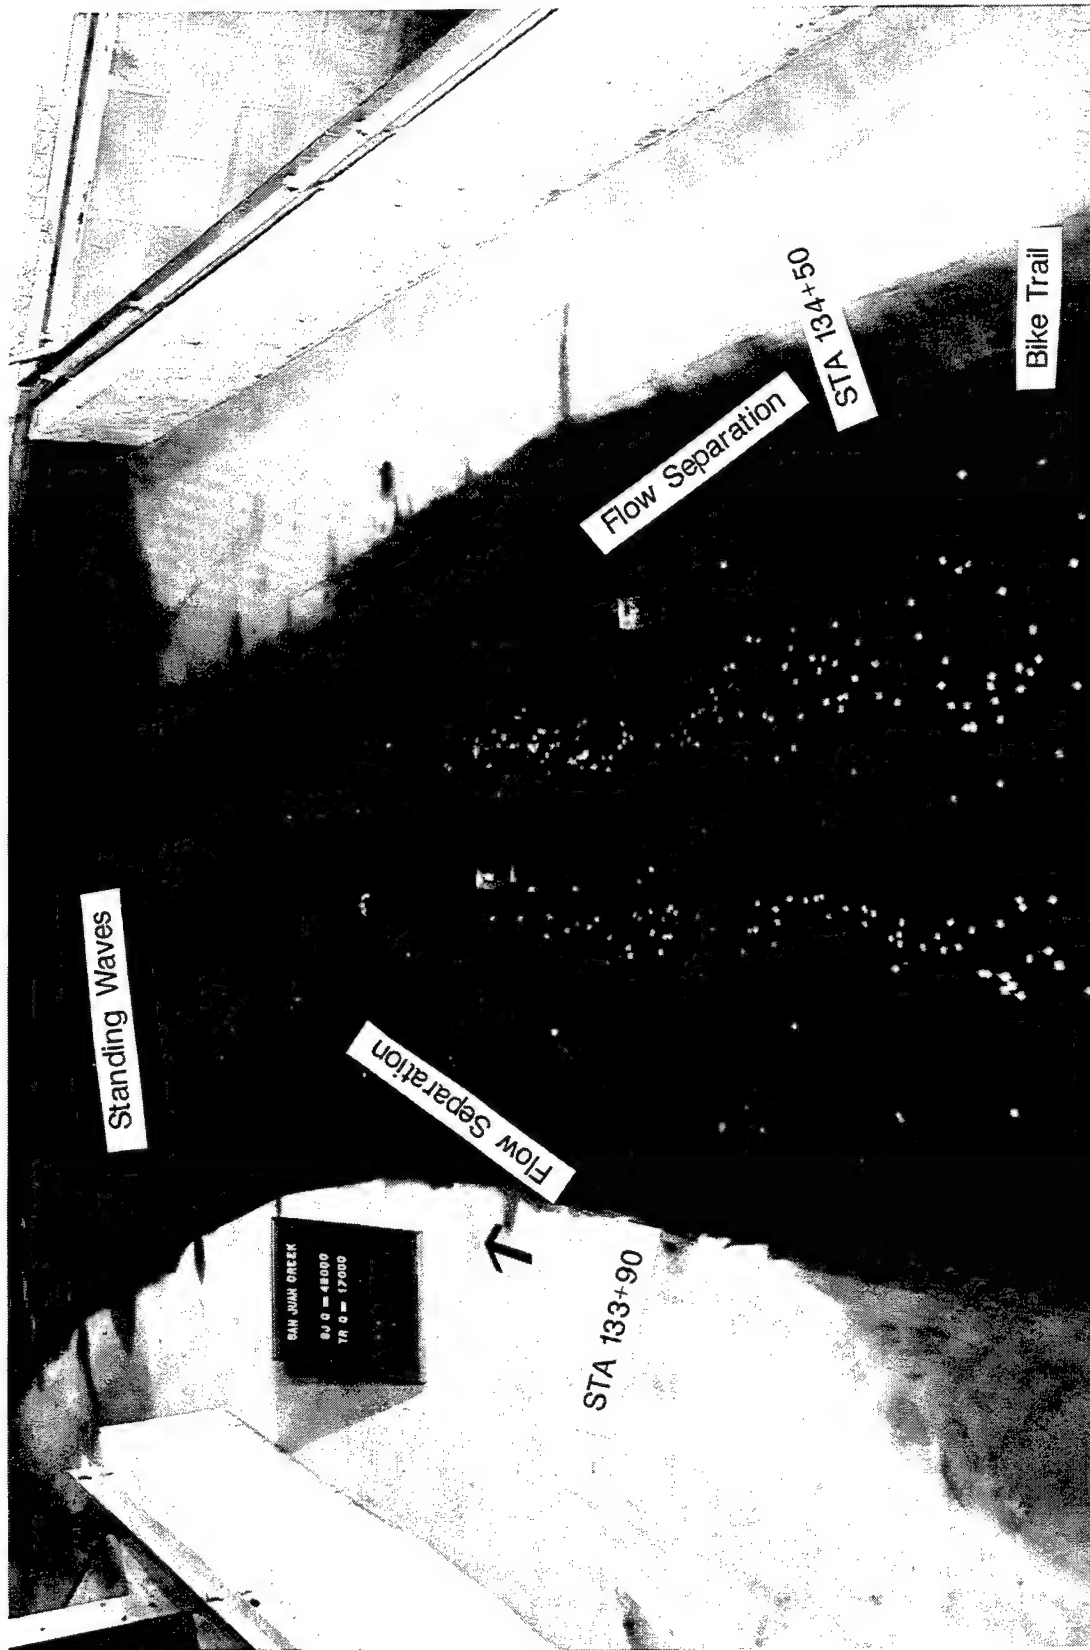
a. Design discharge,  $Q_{sj}$  42,000 cfs (1,176 cu m/sec)

Photo 12. San Juan Creek, type 7 design, flow conditions in the vicinity of the railroad bridge piers, downstream view. Flow separation observed on left bank, created by the side slope transition to a vertical wall, and right bank, created by the bike trail, contributed to standing waves observed. (Sheet 1 of 3)

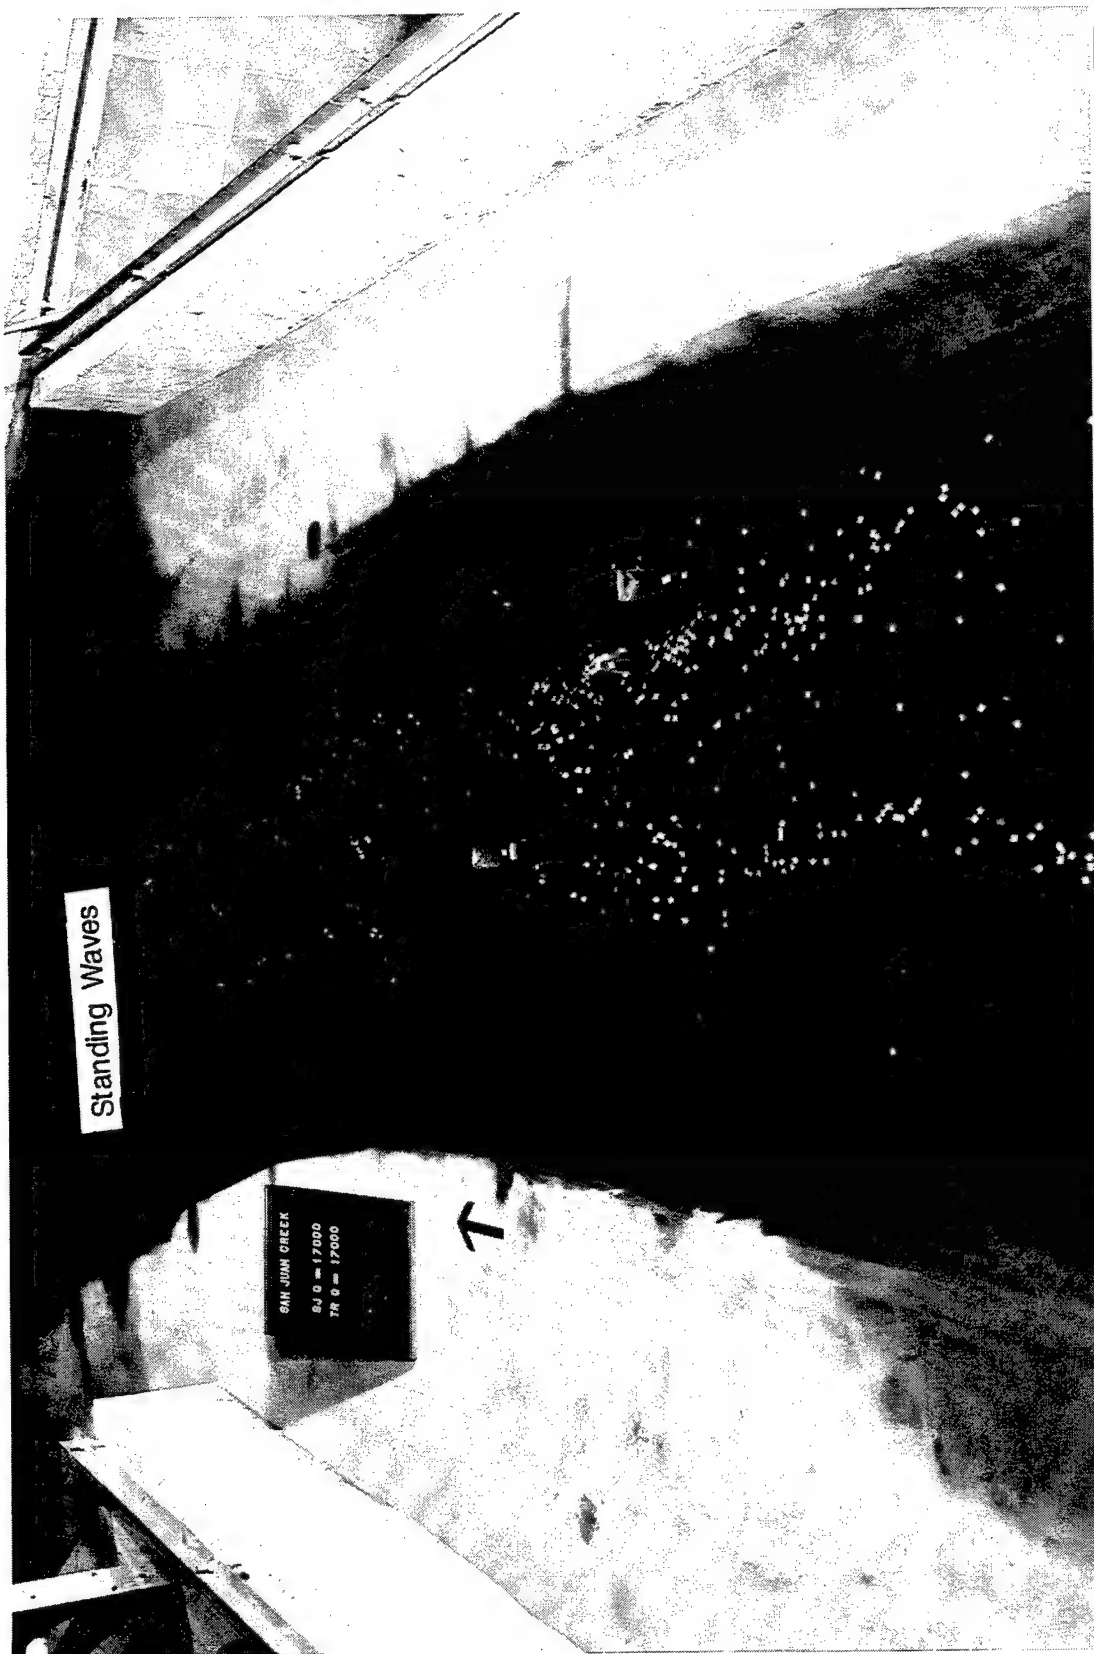
Photo 12. (Sheet 3 of 3)

c. Balanced discharge,  $Q_{sj}$  17,000 cfs (476 cu m/sec)

**Balanced discharges.** Water-surface profiles for San Juan Creek (17,000 cfs (476 cu m/sec)) and along the railroad bridge piers for type 7 design are shown in Plates 46 and 47, and the water-surface elevations for the profiles are tabulated in Tables 11 and 12, respectively. Bottom velocities are shown in Plates 48 and 49. Standing waves created by the railroad bridge piers were observed downstream from the bridge (Photo 12c) and along the bridge piers (Photo 11c). Flow separation occurred on the left embankment at sta 133+90 (Photo 12c) and forced the flow toward the right bank (Photos 12c and 13c). The flow became satisfactory downstream of the confluence at approximately sta 125+00.

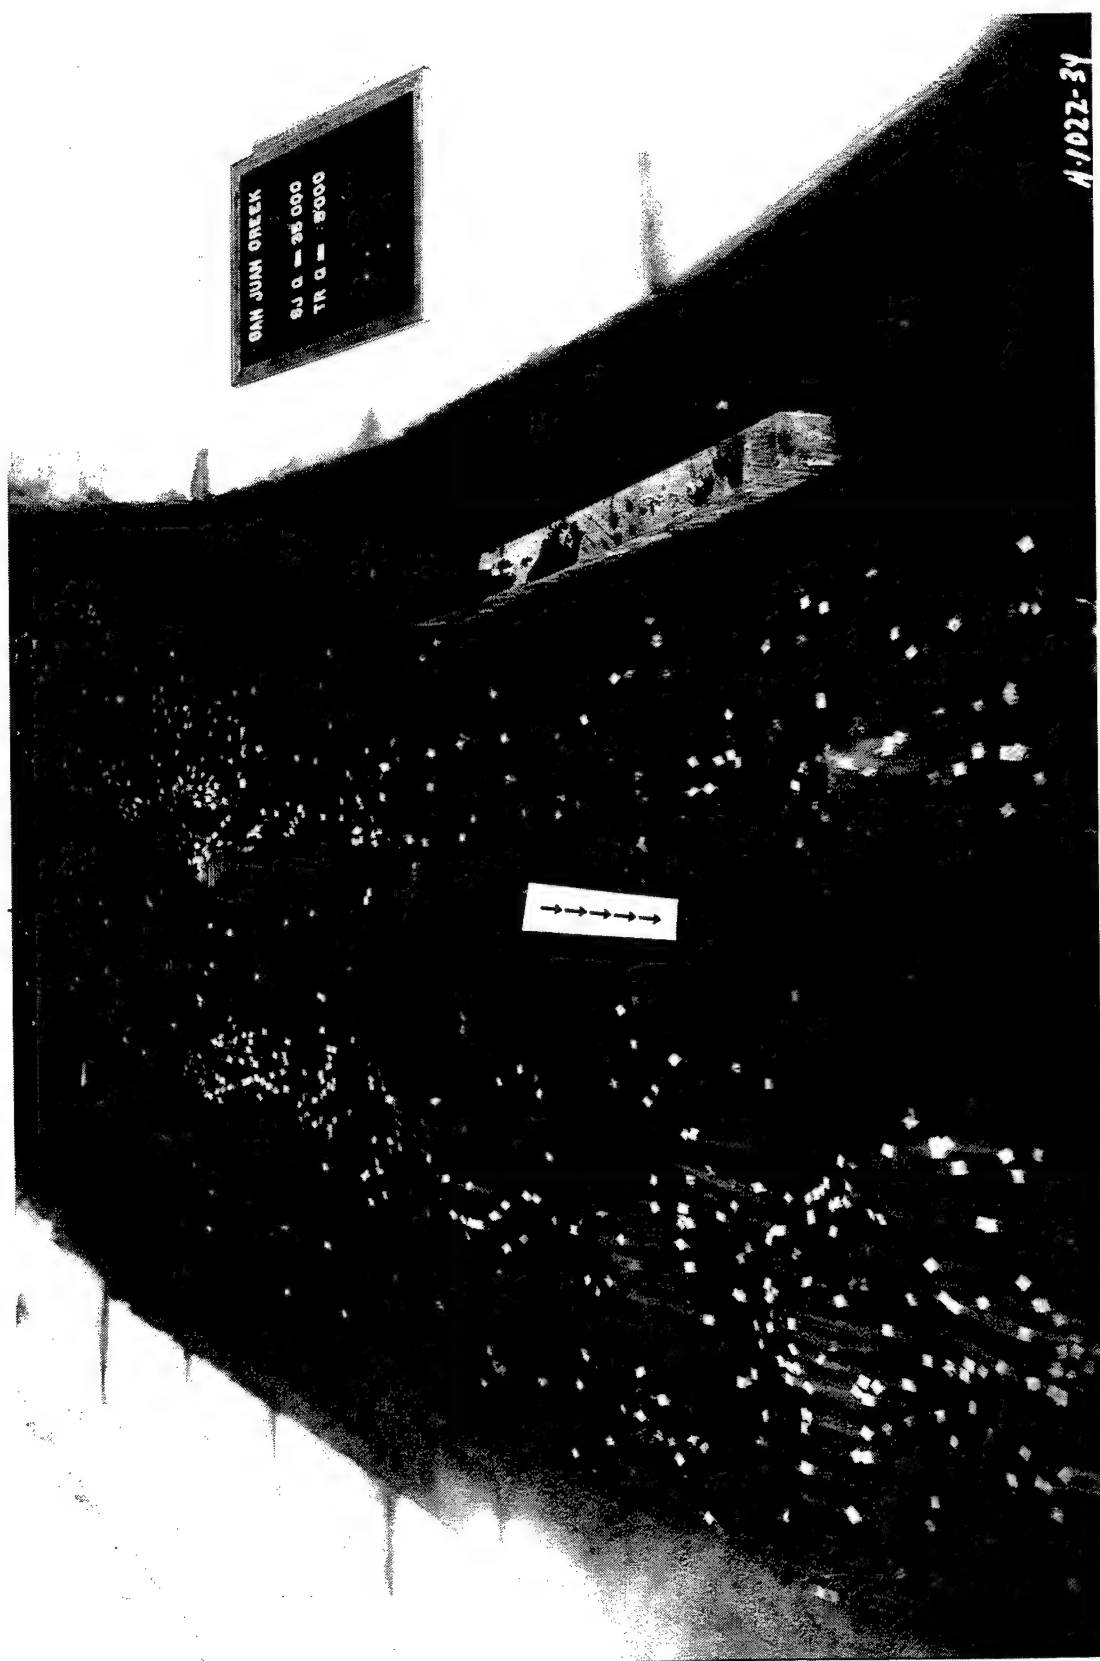
Photo 13. (Sheet 2 of 3)

Photo 13. San Juan Creek, type 7 design, flow conditions in the vicinity of the railroad bridge piers, upstream view. Oblique standing wave observed between center and left piers. Standing waves observed downstream of the railroad bridge. Flow separation on right and left banks forced flow to concentrate in center of channel. (Sheet 1 of 3)

b. Unbalanced discharge,  $Q_{sj}$  35,000 cfs (980 cu m/sec)

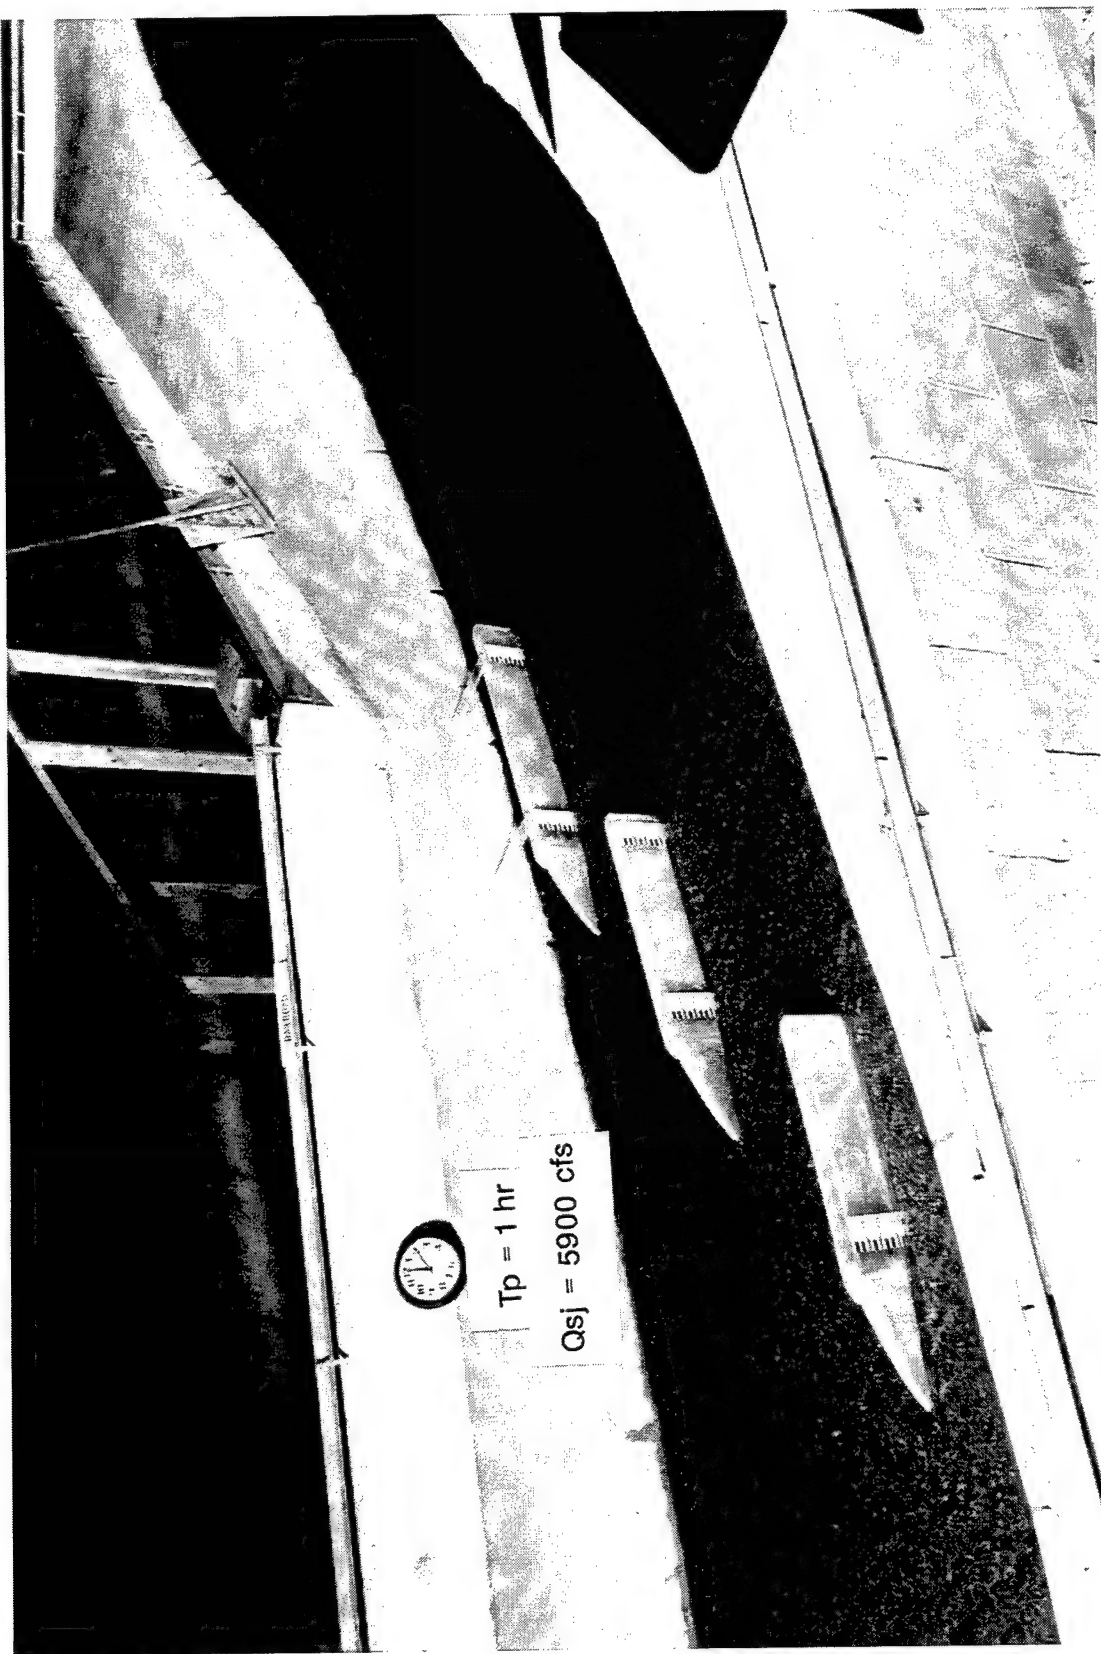
Photo 14. San Juan Creek, type 7 design, flow conditions in the vicinity of the railroad bridge piers during 24-hour storm hydrograph, side view, prototype time 1 hour,  $Q_{sj}$  5,900 cfs (165 cu m/sec)
